A REVIEW OF EXHAUST ELBOW EVOLUTION and RESONANCE REVERSION

Jane Christen, SAMS-AMS®

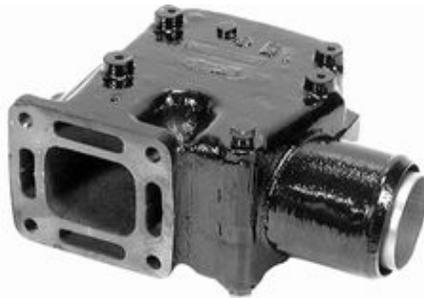
Photo 1.

P/N 98502A2
Fits MIE GM V-8 with
center rise outlet exhaust
manifold.

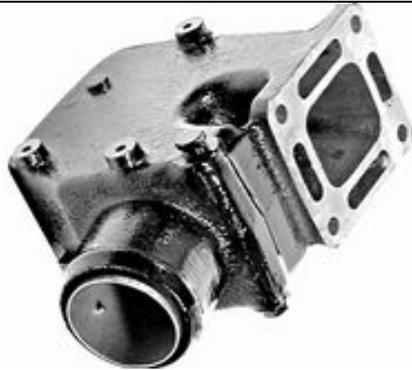
Photo 2.

P/N 98504A3
Fits MCM/MIE GM V-6
& V-8 engines with
center rise outlet exhaust
manifold.

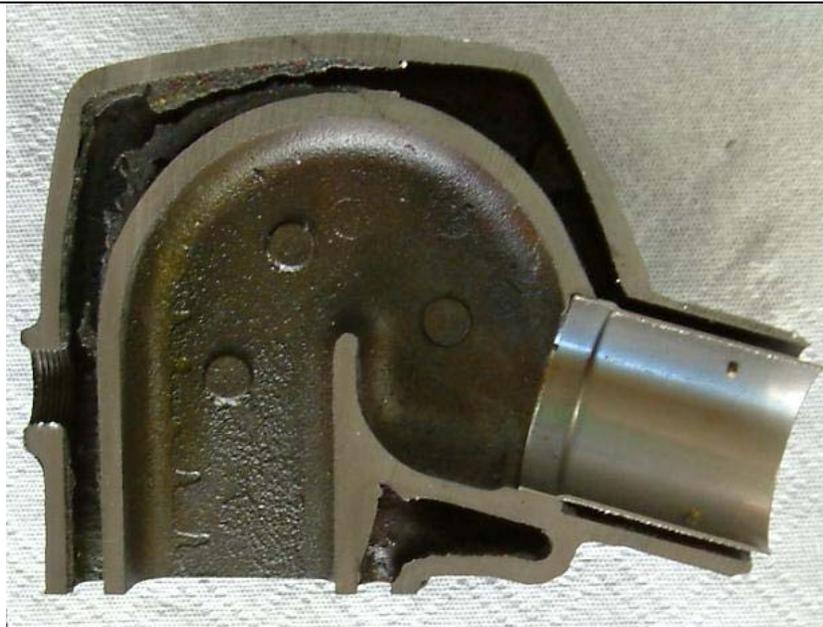
Photo 3

Upon slicing open p/n
98504A3 elbow, we
found there is a very
slight hook towards the
exhaust discharge.

**This appears to be an
effective design to
prevent resonance
reversion.**

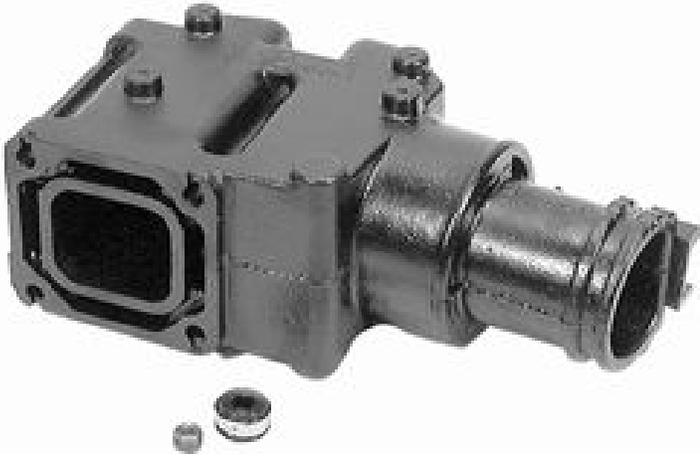
Next Generation: MerCruiser V-6, V-8 and Ski boat engines (excluding those using Gil style pipes, or high performance header and tailpipe) for the years of **1987 through 2002** are now using p/n 807988A2. This exhaust elbow appears from the superceded list to have been designed and put into use about 1998 with the 0L002000 and up serial number engines. P/n 807988A2 is also engineered for the earlier engines, and supercedes four (4) original part numbers on the 1987 through 1998 engines. The Bravo engines of this era originally offered stainless steel elbows (p/n 816900A5, 816900A7, 816900A9) which have all been discontinued. The stainless elbows and the cast iron elbows p/n 807988A2 were all designed to fit the same exhaust manifold, so the cast iron p/n 807988A2 is universal. **The design of this elbow is a major change, in that there is no apparent impediment for resonance reversion.**

<p style="text-align: center;">Photo 4</p>	<p>P/N 807988A2 Fits MCM/MIE GM V-6 & V-8 engines with center rise outlet exhaust manifold</p>

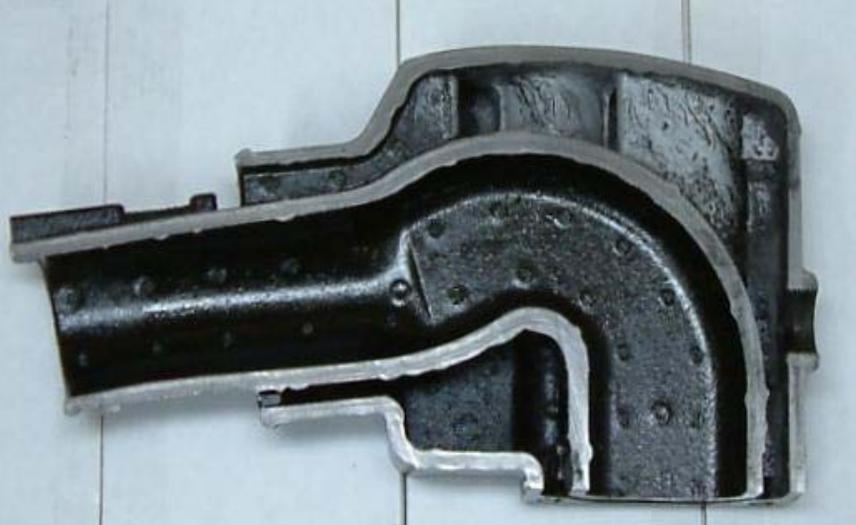
<p style="text-align: center;">Photo 5</p>	<p>Upon slicing open a p/n 807988A2 elbow, it is immediately apparent how smooth a path is present for resonance reversion.</p>

Our research, experience and anecdotal information indicates the introduction of exhaust elbow model p/n 807988A2 around 1998, occurred at about the same time as the electronically controlled engines with more aggressive valve overlap were introduced. The p/n 807988A2 elbow is a 4 inch O.D. with 7 degree down angle casting. This larger size was reportedly introduced for the higher horsepower engines, as everything prior was 3 inch O.D. with either 0 degree, 15 degree or 90 degree down angle.

While a re-designed exhaust elbow with an effective vacuum-break would be of significant help on new engines, the p/n 807988A2 elbow - which is almost universal for the last 15 years of engine production, is worthy of scrutiny. Attention to the complete system on engines of this vintage is prudent. Installation of a Resonator Kit may be beneficial. Maintenance of the internal shutters is also strongly suggested.

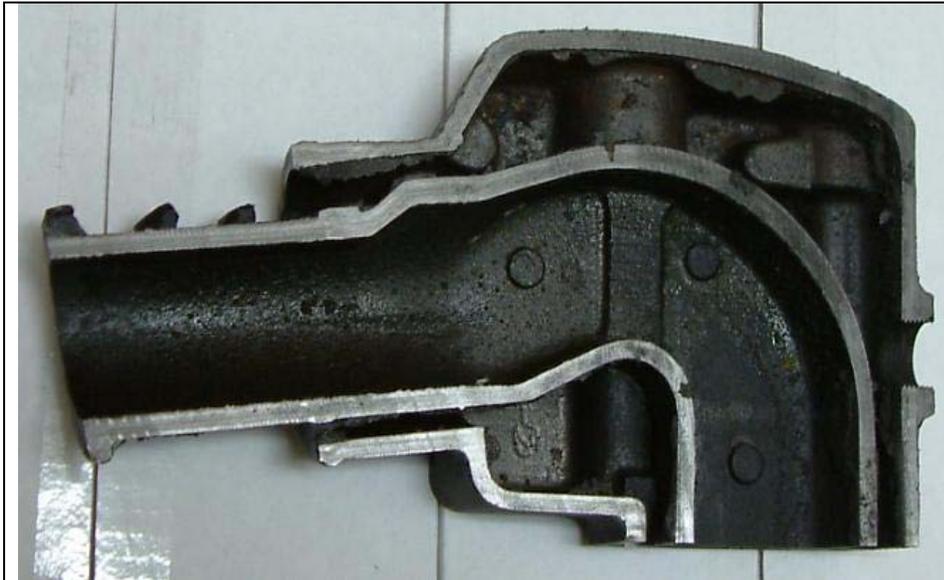
Photo 6

This is the elbow built by Osco for Boat/US. It is an “aftermarket” replacement for MerCruiser p/n 807988A2. It is Osco p/n 4354 and/or Boat/US p/n 274009

Note that this casting has a kink in the top line of the discharge that is not present in the MerCruiser model. Because the kink is in the top line, it appears this would be inadequate to prevent resonance reversion, although it will disturb the exhaust flow and possibly provide some help.

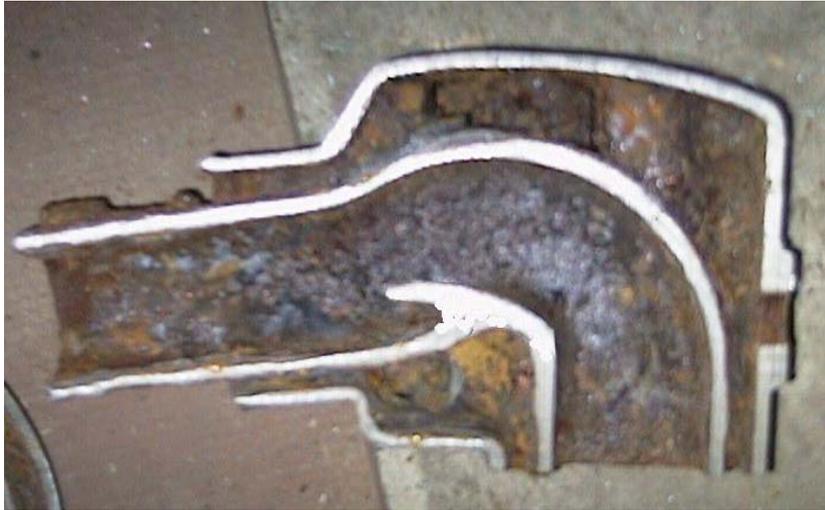
Photo 7. Example of "Vacuum-Break" hook drawn on photo.

The mechanic advised that it was his presumption this casting detail had been lost during redesign by a new crop of engineers that did not know the reason for the lip. He also advised that previously one of the standard diagnostic procedures when inspecting an engine that had suffered water damage was to reach into the back of the elbow and check on the status of the vacuum-break. He explained that this casting detail would eventually erode away from impingement, leaving the engine vulnerable to reversion.

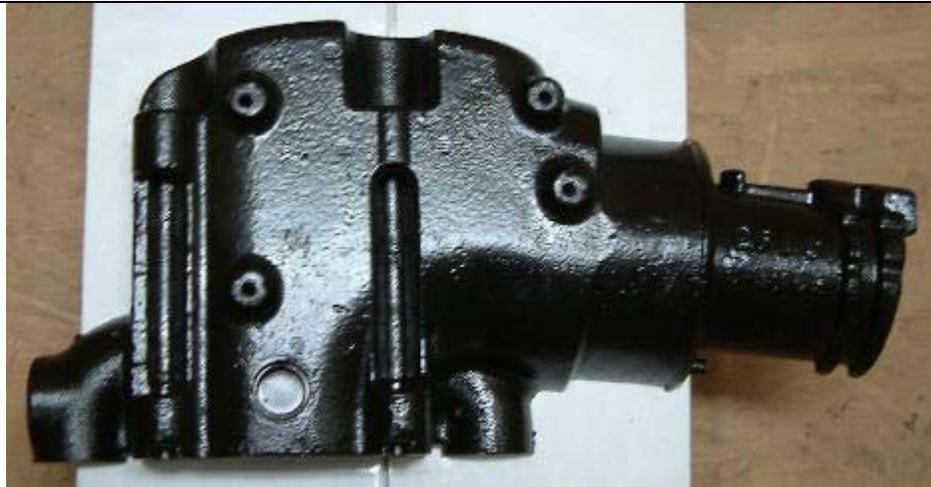
Photo 8

The p/n 864309T01 elbow is a “dry joint” elbow. Note the water passages buttressed around the exhaust joint where the elbow mounts on the manifold.

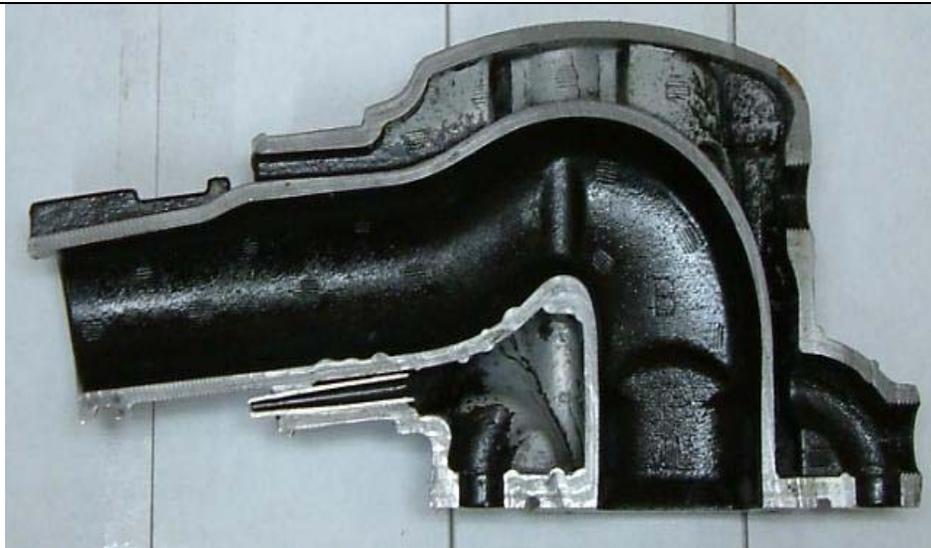
Photo 9

This elbow is essentially the same as p/n 807988A2 with the water loop added for the dry joint. There is a slightly irregular hump in the upper line of the discharge pipe. **No indication of an effective vacuum-break is observed.**

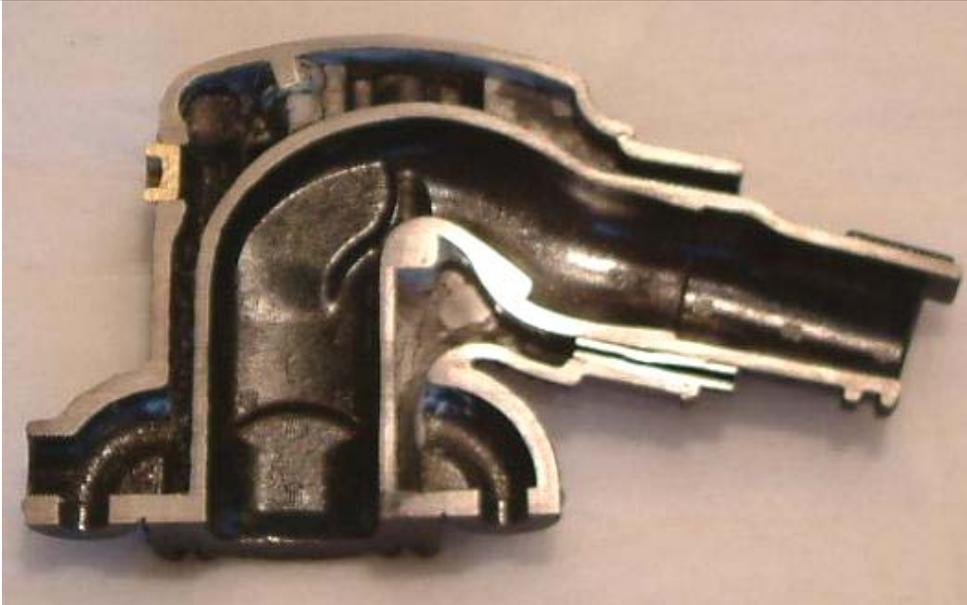
Photo 10

This is p/n 864591T02. The vacuum break casting detail is highlighted in the photo.

Dry joint elbow requires exhaust manifold p/n 865029T01.

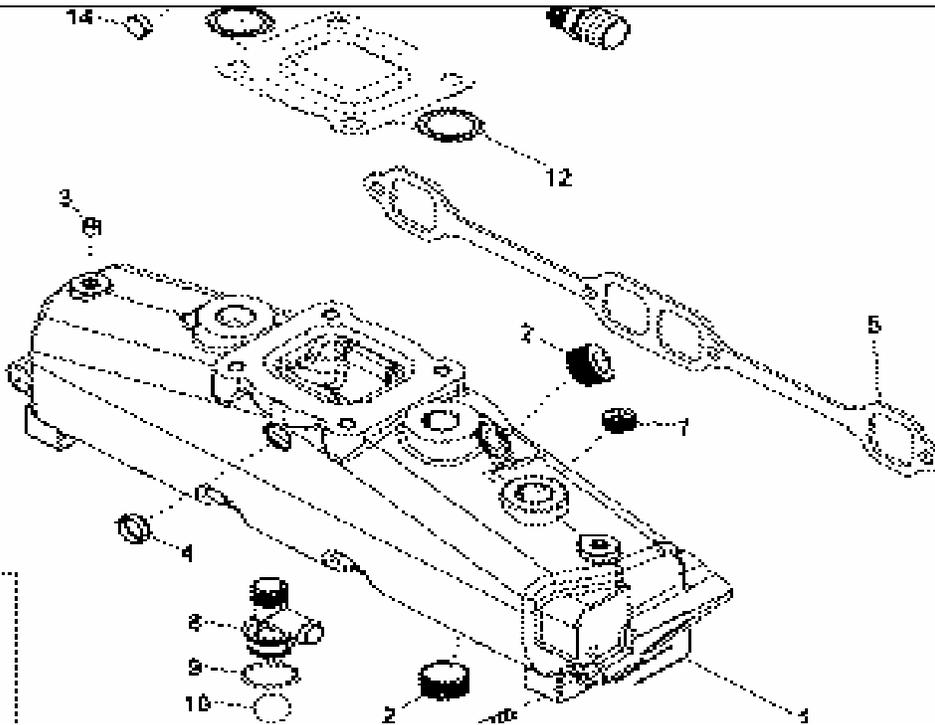
This is exhaust manifold p/n 865029T01. This manifold has the water connections for the dry joint exhaust elbows.
