CRITTER ALERT

Jane Christen, AMS®

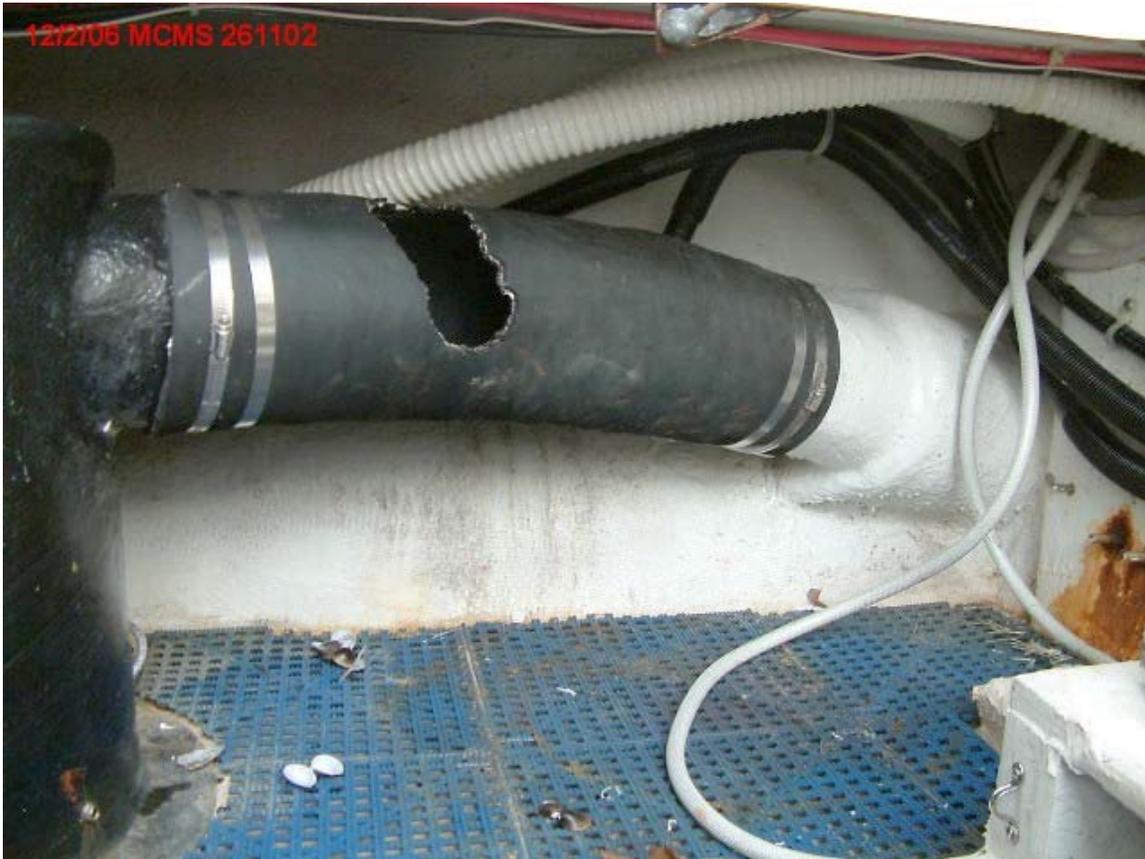
The hole in this hose is 6.5 by 2.5 inches and the bottom of the opening is even with the static waterline. Note small clamshells deposited under hose.

The critter usually chews through the top of the exhaust hose just above the internal water line. It is hard to believe that by using claws and teeth a critter can get a hole started in this very tough hose material.

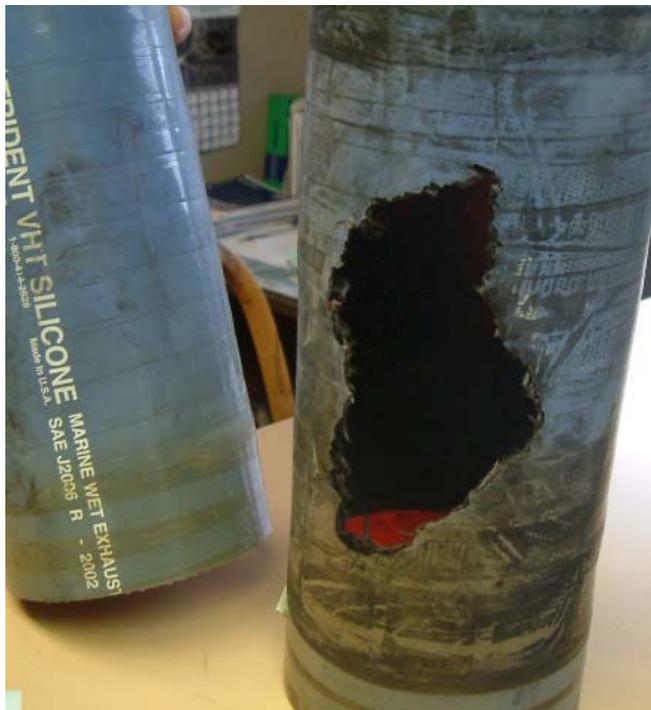
Whenever the boat is hauled, use a flashlight to look up the exhaust and check for indications of critter activity.

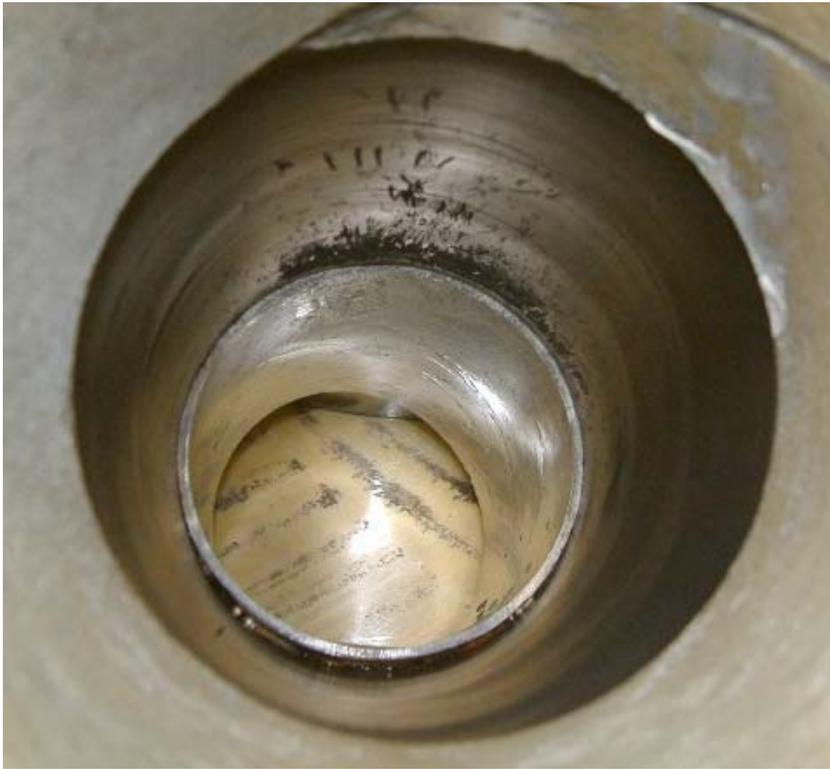
If the boat is afloat, carefully look at the exhaust hoses. It is unlikely you will be able to determine if the inner portion of the hose has been chewed away, but it is not unreasonable to give the hose a squeeze in a few places to see if it feels soft at the upper end.

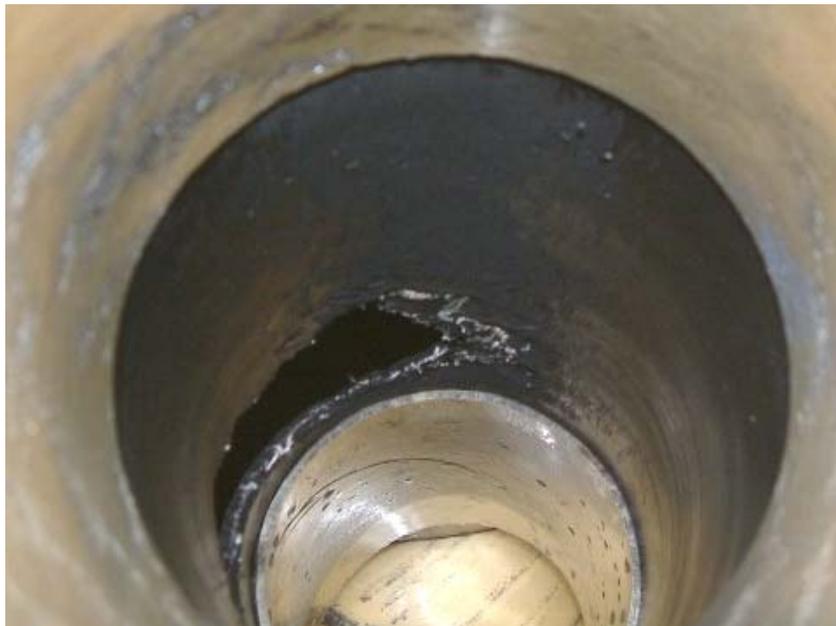
The structure at the forward end of these photos is the water lift muffler.

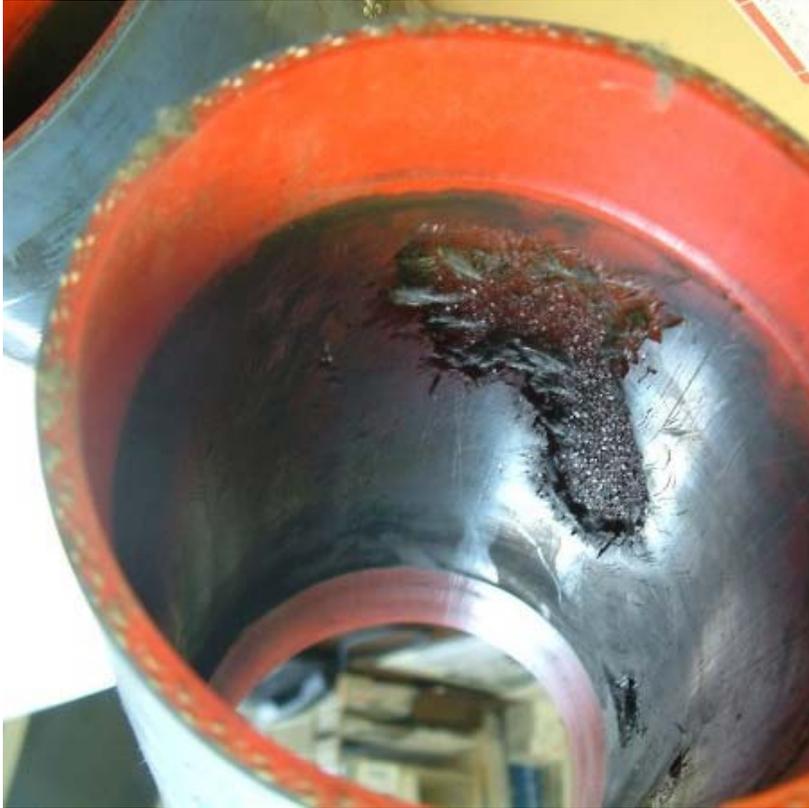
As visible in this photo, the critter often starts gnawing away at the inside surface of the hose over a period of time – without going through to the outside of the hose.

Because part of the gnawed away surface of the inside of this hose is blackened by soot, and other areas are less black, it is possible the engine was operated after the damage was started and the critter returned to do more damage at a later date.

Note that much of the interior layer of the hose has been removed all around the part that has been holed.

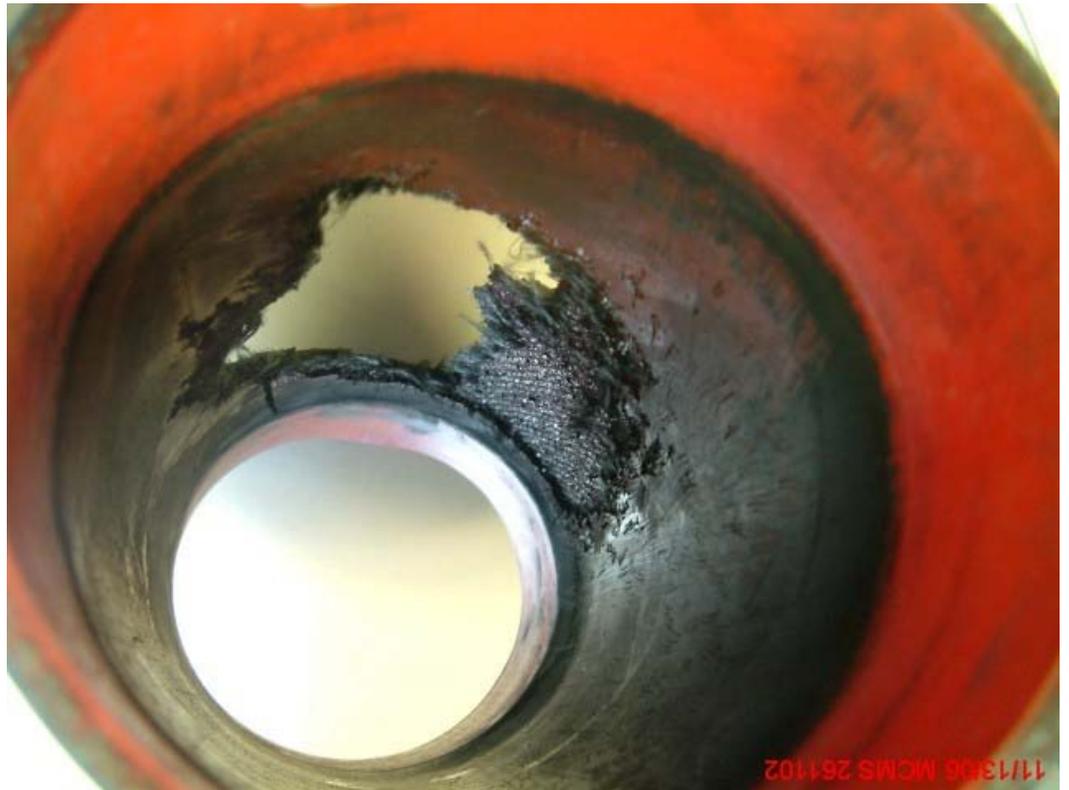
A variety of measures can be used to repel rodent invaders, including everything from window screen to barred fittings over the exhaust. Dunato's of Seattle, WA sells an adjustable fitting that installs inside the discharge pipe and is held in place by friction when the threaded bars are turned to extend the fitting.
